# Investigation of Failure Mechanisms and Migration of Industrial Chemicals at Wilsonville, Illinois

Research and Development | EPA/600/M-89/033 | July 1990

# ENVIRONMENTAL RESEARCH BRIEF

## INVESTIGATION OF FAILURE MECHANISMS AND MIGRATION OF INDUSTRIAL CHEMICALS AT WILSONVILLE, ILLINOIS

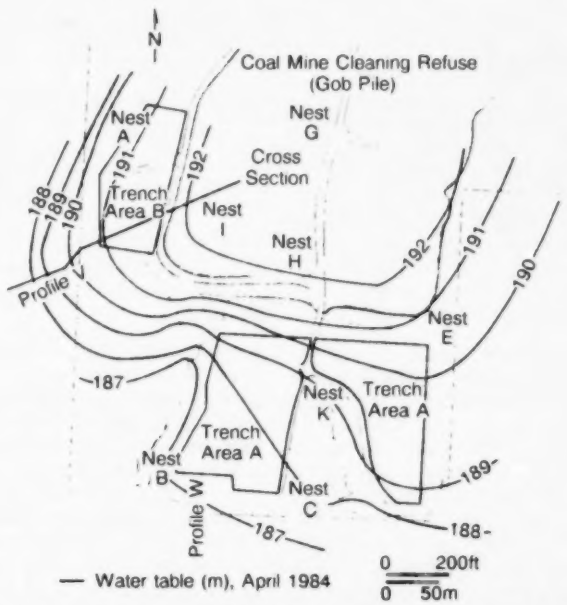
**Figure 1. Map showing water table elevation (m) in April, 1984; locations of trenches, wells and cross section.**

ISGS monitoring well piezometers and SCA monitoring wells were used to measure the potentiometric surface in each zone. The water table is shown in Figure 1. Potentiometric surfaces of deeper zones showed the same general pattern with lower water levels, indicating that the zones are connected and the vertical gradient is downward. Figure 1 also shows the influence of the gob pile on groundwater flow at the site; groundwater flows radially outward from the gob pile.

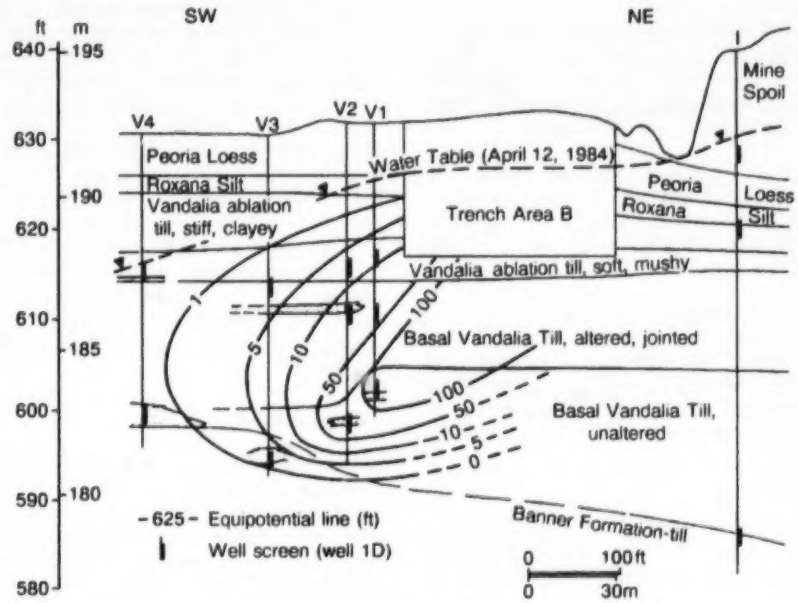
Monitoring well results indicated that organic compounds were also found in the unweathered Vandalia Till. A typical contaminant distribution pattern with trichlorethylene used as an example, is shown in Figure 2. The highest levels of contamination on the site were found on the southwest corner of French Area A, at nests W1 and B, in the unaltered basal Vandalia, where endrin and dieldrin were

present in concentrations greater than 1%. High levels of contamination in the unaltered Vandalia suggest that contaminants are moving downward through sand lenses and interconnected joints.

***Figure 2.*** **Cross from Profile V through Trench Area B to the gob pile showing distribution and trichlorethylene (ppb) in groundwater, September 1984.**
